# 2014 GT3 Engine Failures

Understanding what's causing the catastrophic rod bolt failures

STORY BY TONY CALLAS AND TOM PRINE AND PHOTOS COURTESY OF PORSCHE

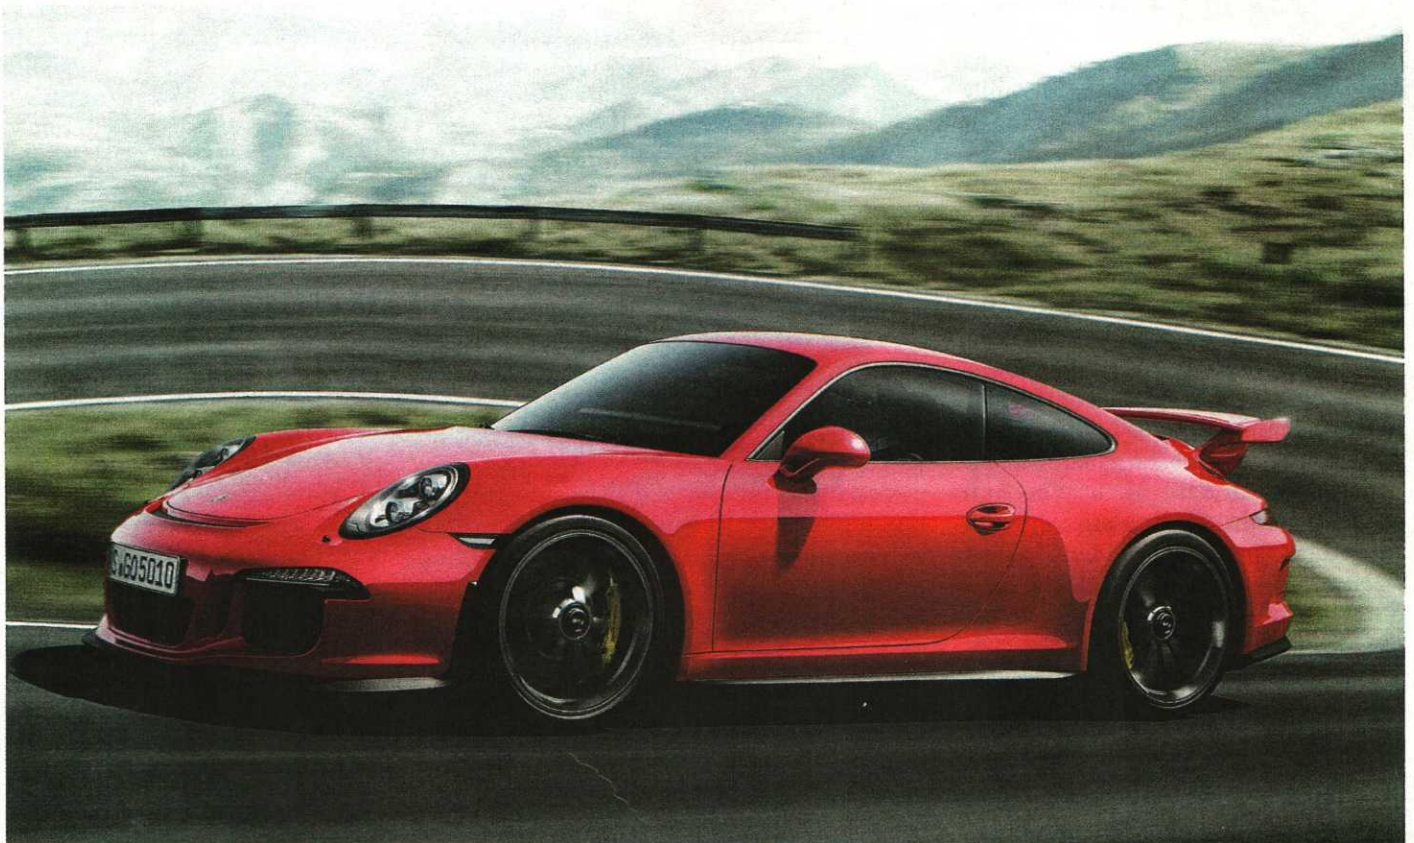
Above: The 2014 911 GT3 is an impressive car, but its reputation has been marred by a few much-publicized engine fires caused by rod bolt failures.
