# RMS: Tales of M96 Woe

BY TONY CALLAS AND TOM PRINE

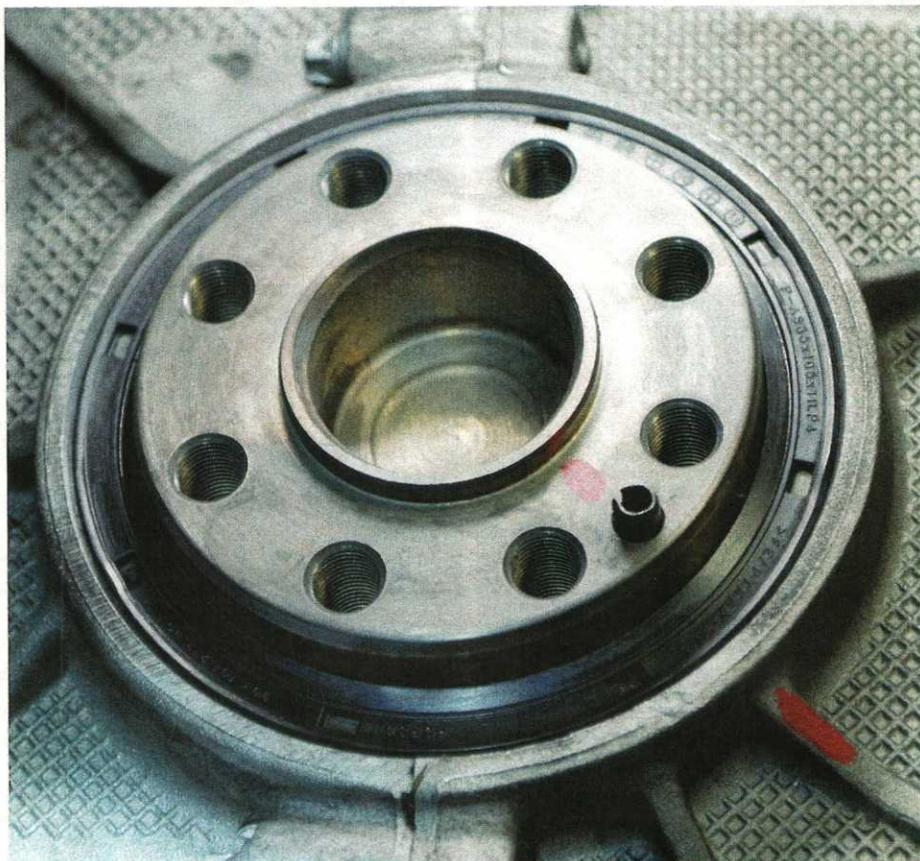
**Crankshaft and rear main seal (RMS), one of the problem areas for the new M96 engine.**

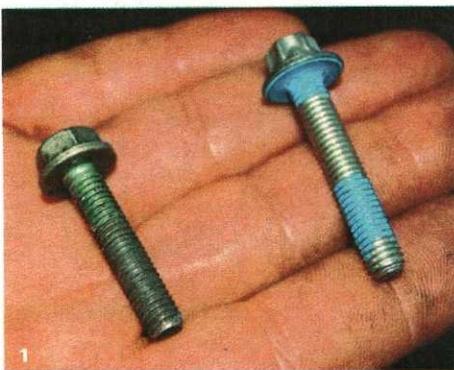
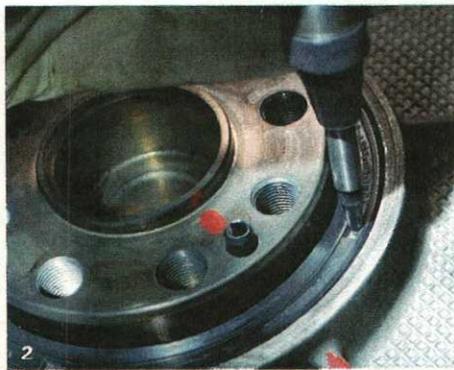
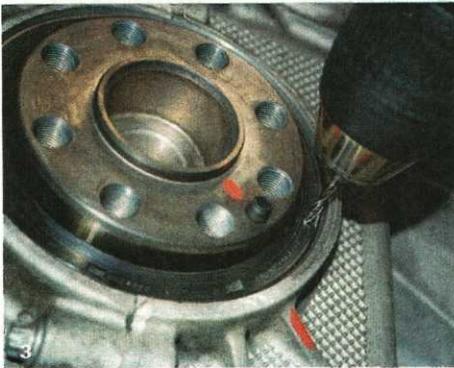
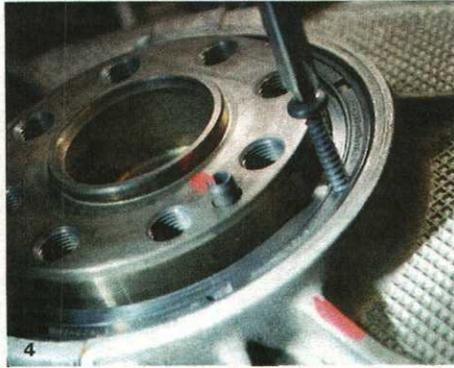
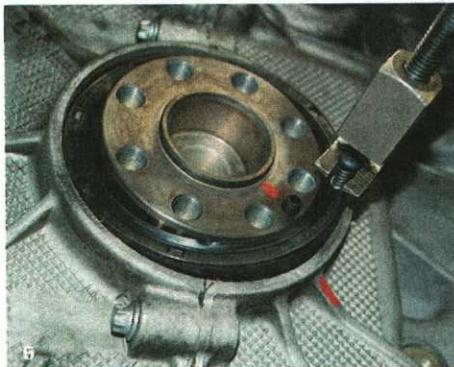
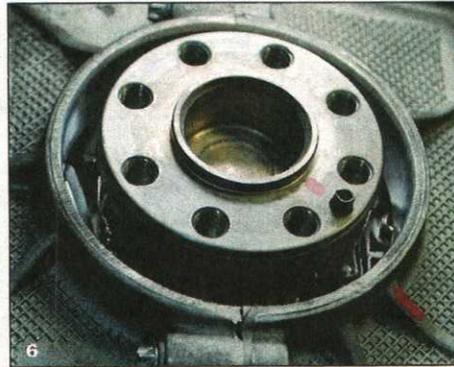
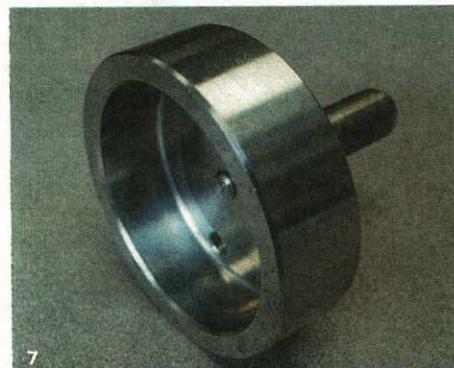
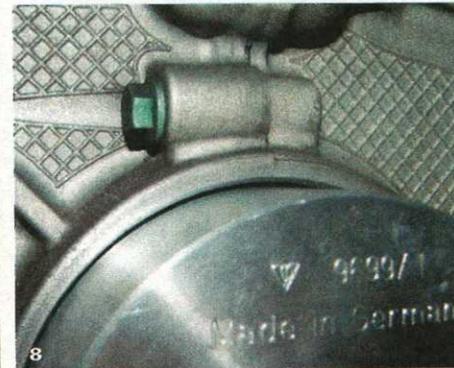
Note the length difference and encapsulated thread-locking compound of the crankcase replacement bolts (1). Using a punch to indent RMS for drilling (2) and drilling through the seal material (3). Firmly install a sheetmetal screw, but not too deep (4). Using a slide hammer to extract the RMS (5). With the RMS removed, it's time to check for crankshaft offset (6). The business end of special tool 9699/1, the Go, No Go gauge (7). This engine has a problem, as the bottom of the Go, No Go gauge is hitting the crankcase and a noticeable gap can be seen at the top of the gauge in this close-up (8, Henry Hinck photo).

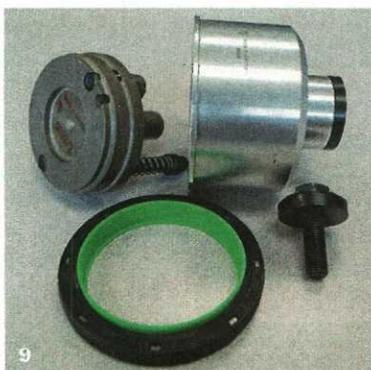
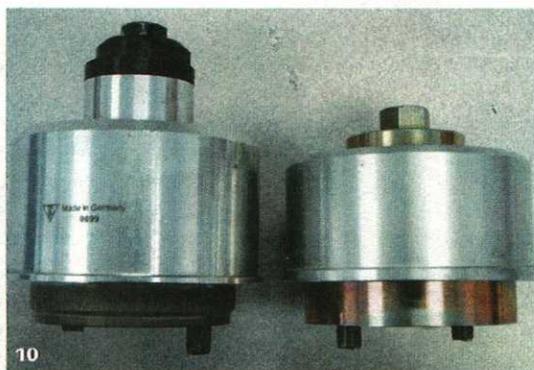
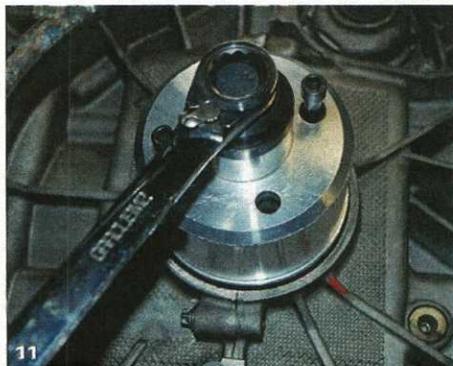
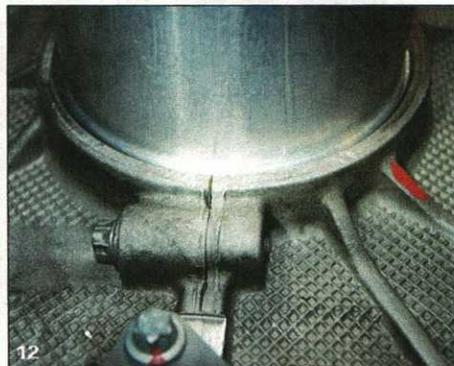
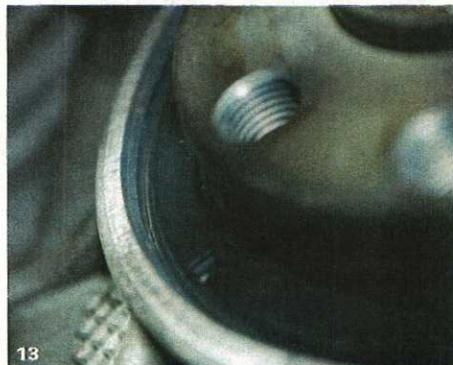
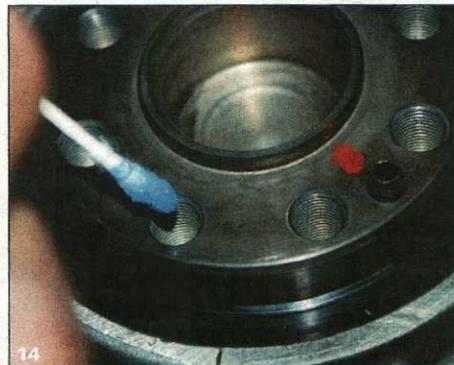
PTFE RMS, special tool 9699, and 9699/2 insert guide (9). Special tool 9699 on left, next to original tool 9609 (10); note difference in the mounting bell depth. With tool 9699 attached to the crankshaft, the 19-mm bolt is rotated clockwise, pushing PTFE RMS into position (11). 9699 install tool nears completion of its job (12). Close-up view of critical installed depth of RMS (13). Apply enough Loctite #242 inside the crankshaft bolt hole so it cannot make its way to the flywheel mounting surface (14).
