# 2014 GT3 Engine Failures

Understanding what's causing the catastrophic rod bolt failures

STORY BY TONY CALLAS AND TOM PRINE AND PHOTOS COURTESY OF PORSCHE

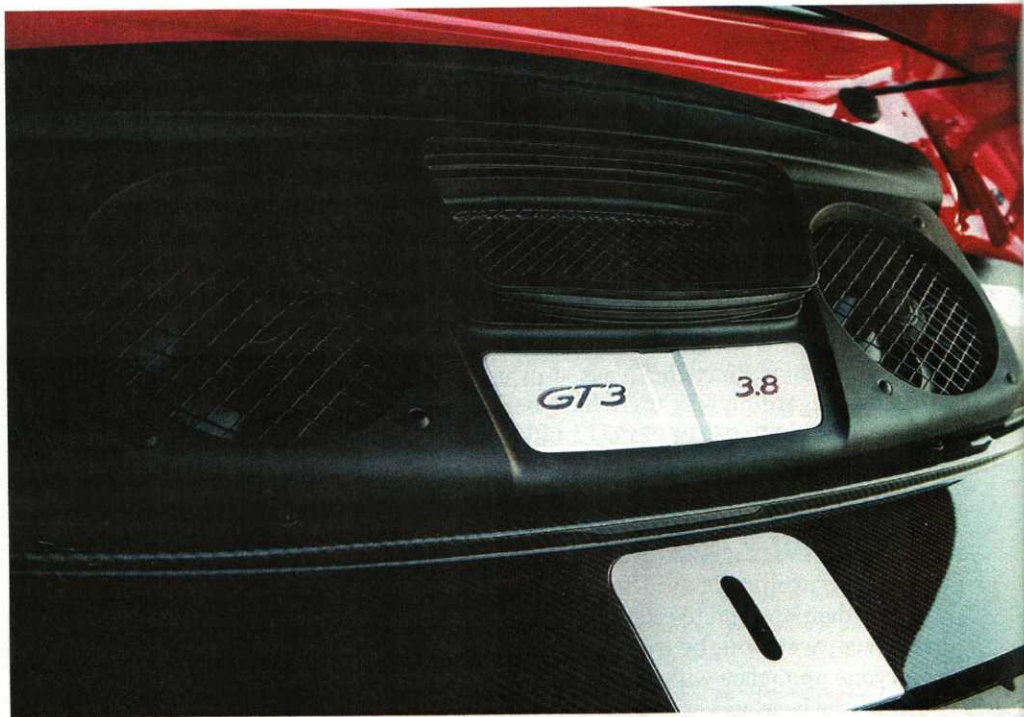
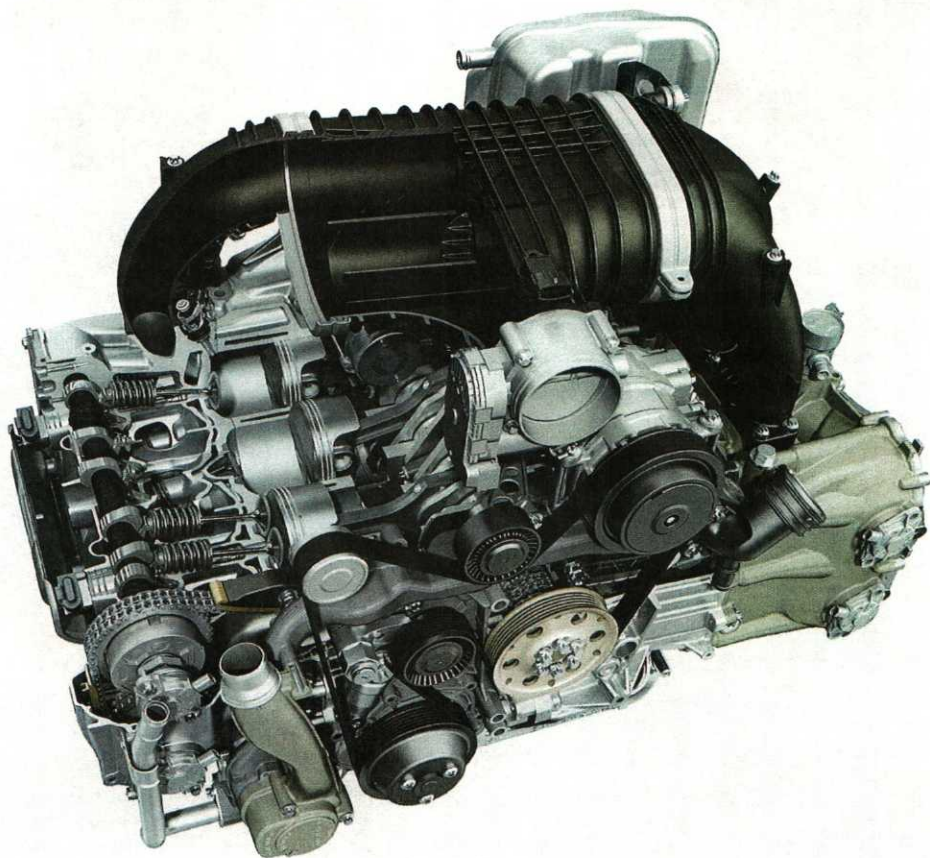
**Above:** The GT3's 3.8-liter flat-six has a factory redline of 9,000 rpm and puts out 475 hp at 8,250 rpm and 325 ft-lb of torque at 6,250 rpm. This output is good for a 0-60 time of 3.3 seconds and a top speed of 195 mph.
