Pre-purchase Inspections 101

Part 2: Save big money by spending a little for a thorough examination.

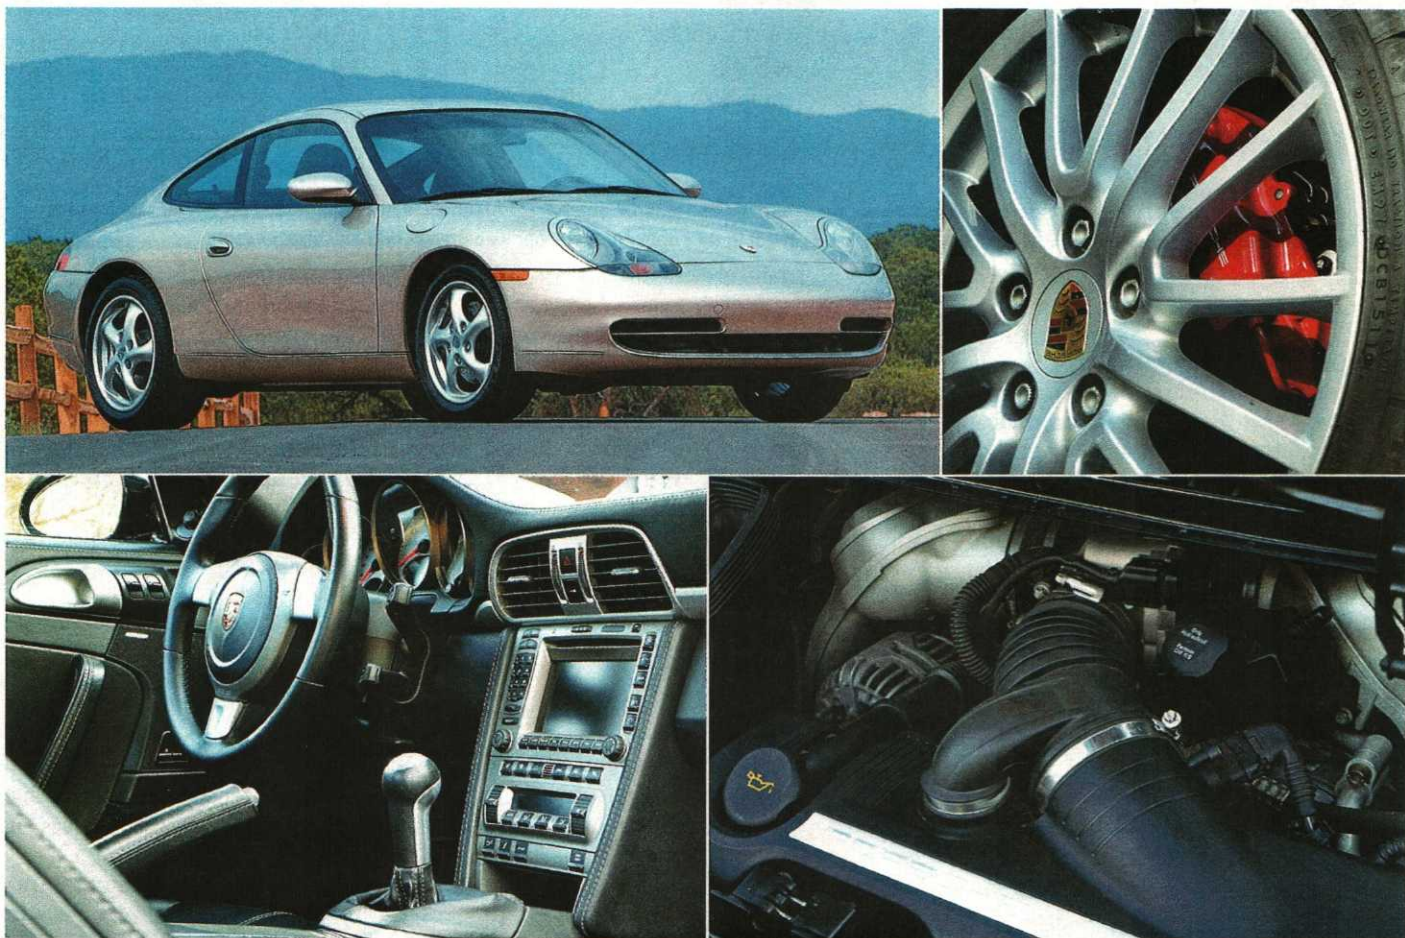
A thorough PPI should involve a factory Porsche Integrated Workshop and Information System diagnostic computer.

Part of a thorough PPI of any computer-controlled Porsche should involve the use of a factory Porsche Integrated Workshop and Information System (PIWIS) diagnostic computer, or the diagnostic computer available to that repair facility to access and interrogate the vehicle's onboard computers. Not all non-factory automotive diagnostic computers have the same capabilities or access to the onboard data of every year and model
