## **Questions & Answers**

BY TONY CALLAS AND TOM PRINE

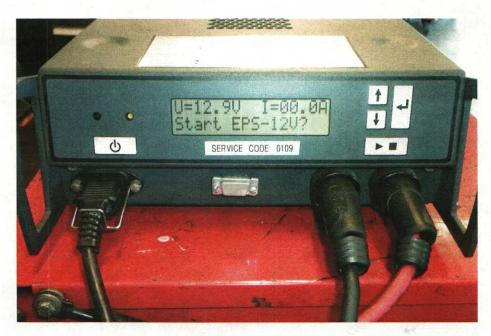
Above: The backup power supply we use to ensure that volatile memory is retained whenever battery disconnection is required. If, however, airbag/POSIP/MRS systems require work, the car must be powered down with no backup power to ensure safety when handling explosive components. Afterwards, the car's volatile memory must be reestablished.

ing a memory-saving device that plugs into the cigarette lighter. These devices operate with a standard 9V battery to retain all control unit capacitors' voltage, preserving the volatile RAM memory. You can obtain one of these devices from various suppliers for approximately \$10.
