Questions & Answers

What do I need to know about welding on a modern Porsche chassis?

Gas smell in 944 S2

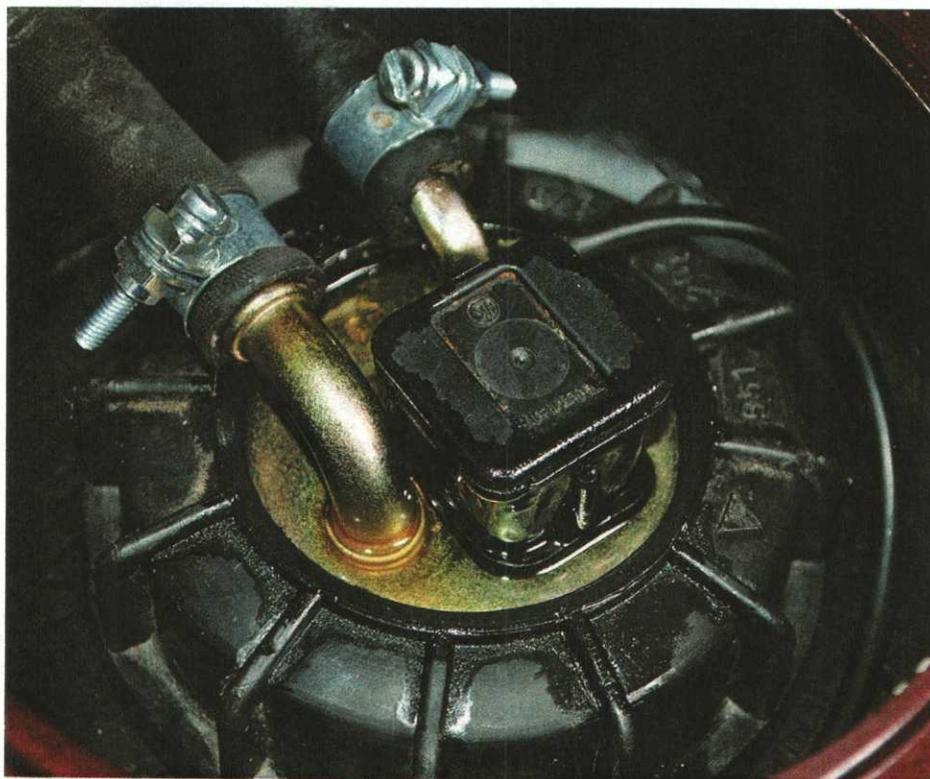
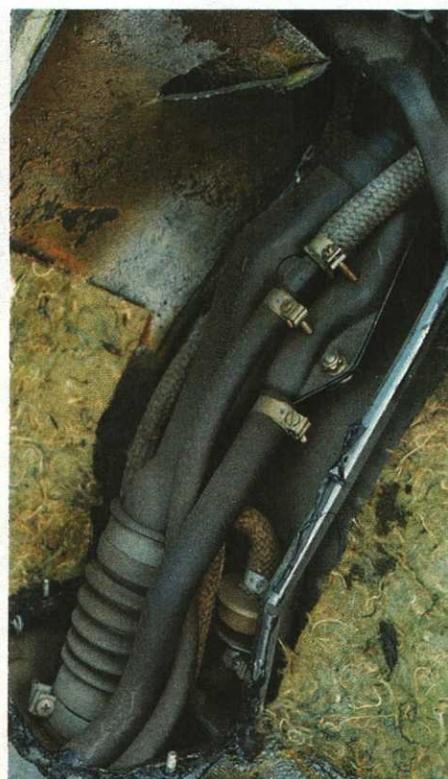
Gasoline can pool around the fuel-level sending unit (left), making the interior smell, but vent hoses in the rear storage area on the passenger side "hump" are the most likely source of gasoline fumes inside a 924/944/968. Remove the carpeting and the cover panel to access the hoses.

That said, there are potentially multiple issues that could cause this symptom. The most likely problem — and the easiest to diagnose — occurs when one or more of the fuel tank vent or filler hoses becomes loose or cracked. Removing the carpeting from the trunk in your Cabriolet or the rear storage area in a 944 coupe will reveal a cover panel on the right (passenger) side of the car, above the fuel tank. Removal of this cover will expose the fuel tank's filler and vent hoses. Check for any loose fittings or damaged hoses, as this

Another likely scenario is if the rubber gasket for the fuel-level sender has failed and requires replacement. When this gasket fails, it allows raw fuel to escape and pool around the top of the sending unit. Likely the smell is worst just after filling the gas tank. All of the 944s, plus the 968-series cars, have a fuel-level sending unit on top of the gas tank, which is accessible in the trunk of the Cabriolet and in the rear storage area under the rear hatch window in coupes. Remove the carpet covering and you will see a circular opening on the passenger side.

On 1985.5-and-later 944s, there will be a black union ring cap surrounding a cable plug and two hose connections. We expect that you may see gasoline around the fuel-level sender when you get to this point. With the union ring cap removed, the gasket can be replaced. The gasket part number is 944.201.327.00, and the same gasket is used on all 944 and 968 models from 1985.5 through 1995.

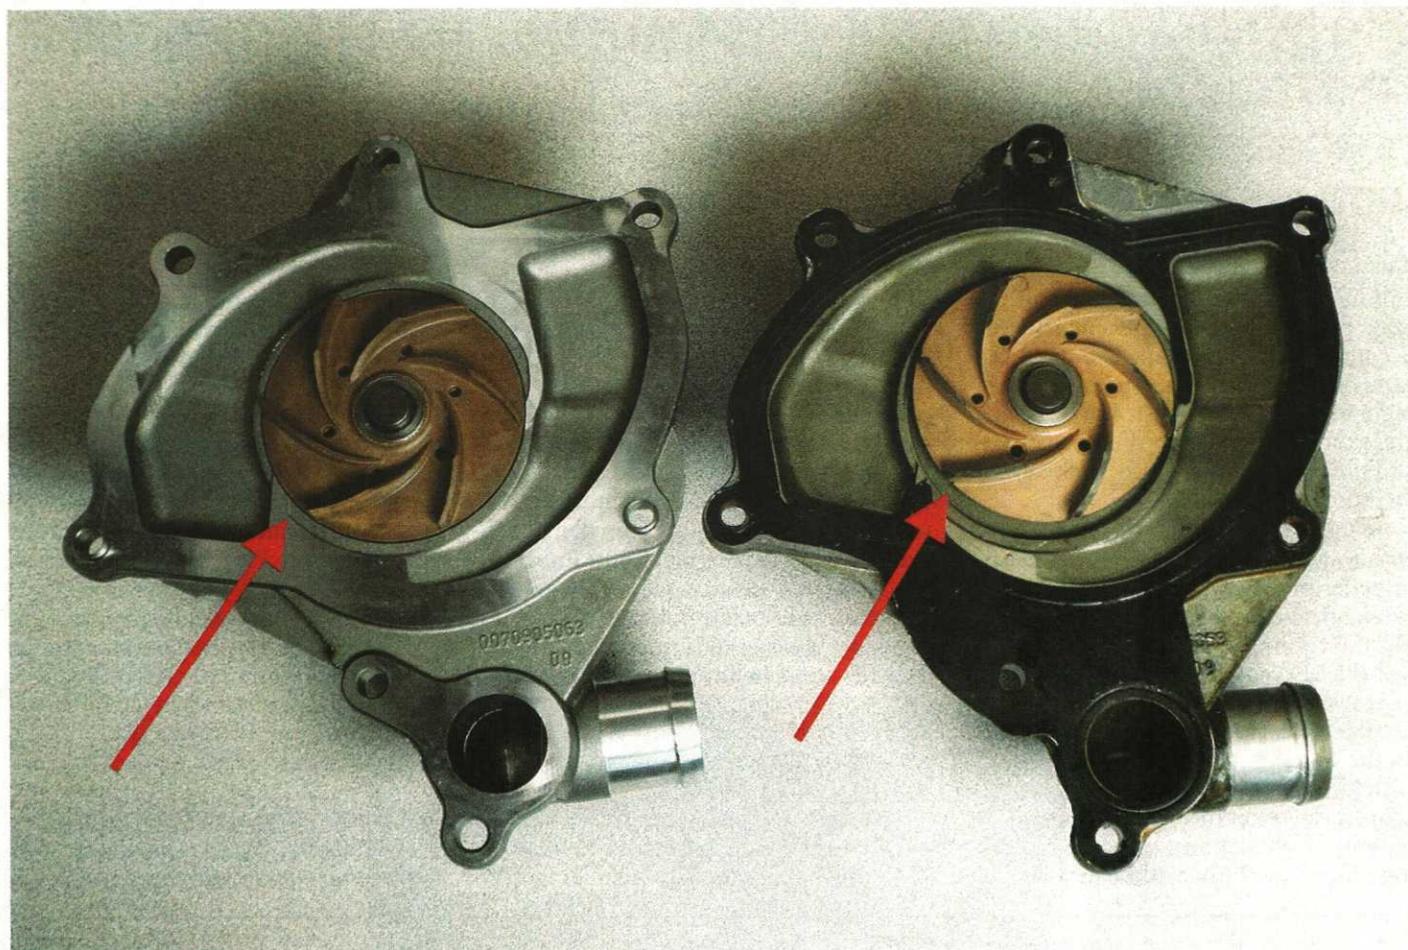
A new water pump (left) and a used water pump with 55,000 miles (right). A worn impeller-shaft bearing increases blade wear (red arrows).

engine, where broken-off pieces of the water pump's impeller blades circulate and become lodged in the small coolant passages of the heads. This restriction or complete blockage of coolant flow in some areas can then lead to localized hot spots and ultimately cause cracks in the cylinder heads.

Many of the M97 engines are equipped with water pumps that also utilize plastic impeller blades, which can deteriorate, break off, and spread this debris throughout the cooling system in the same way that the M96 engine does. The likelihood of cracked cylinder heads in the M97 is not the issue. However, if multiple blades on the water pump's impeller break off, a reduction in coolant flow, pressure, and volume can result throughout the cooling system, which may lead to a drop in cooling efficiency. This could cause higher
